National Aeronautics and Space Administration

NASA-DoD Lead-Free Electronics Project

DRAFT Joint Test Report

July 2011

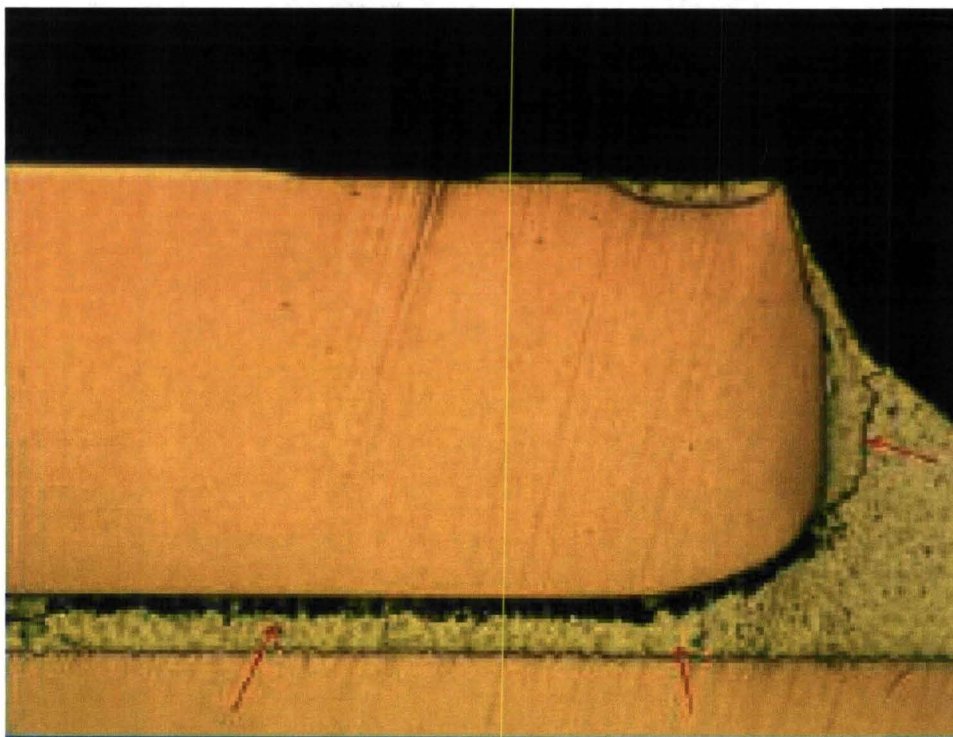
Figure 8 - SN68 U28, Right Side Pad

All of the QFN-20 packages were fabricated using Sn finish and were exposed to one or two reworks with SnPb solder. Approximately half of the solder joints exhibited cracks which ran along the component pad. There does not appear to be a correlation between the cracked solder and the number of re-work cycles to which the part was exposed. Cross sections of the QFN-20 packages reveal that the cracks propagated along the component pad, see Figure 7 and Figure 8.

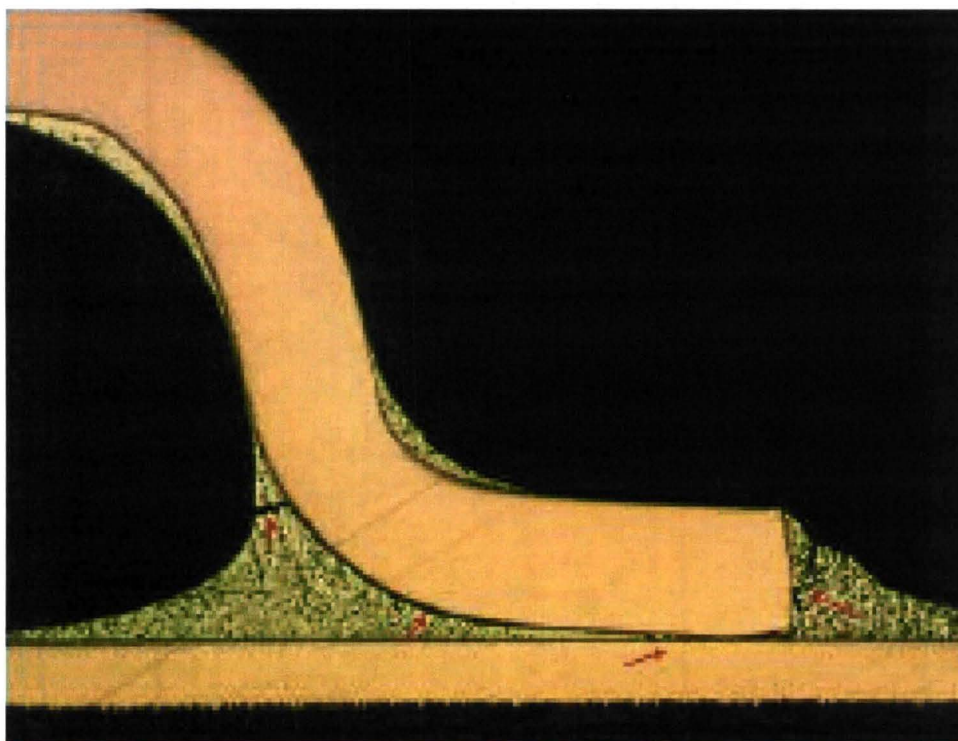
Figure 12 - SN68 U31, Right Lead

Cross-sections of TQFP-144 packages which were re-worked, either once or twice, revealed cracked solder joints in all cases. However, all of the leads on these samples survived, see Figure 11 and Figure 12.

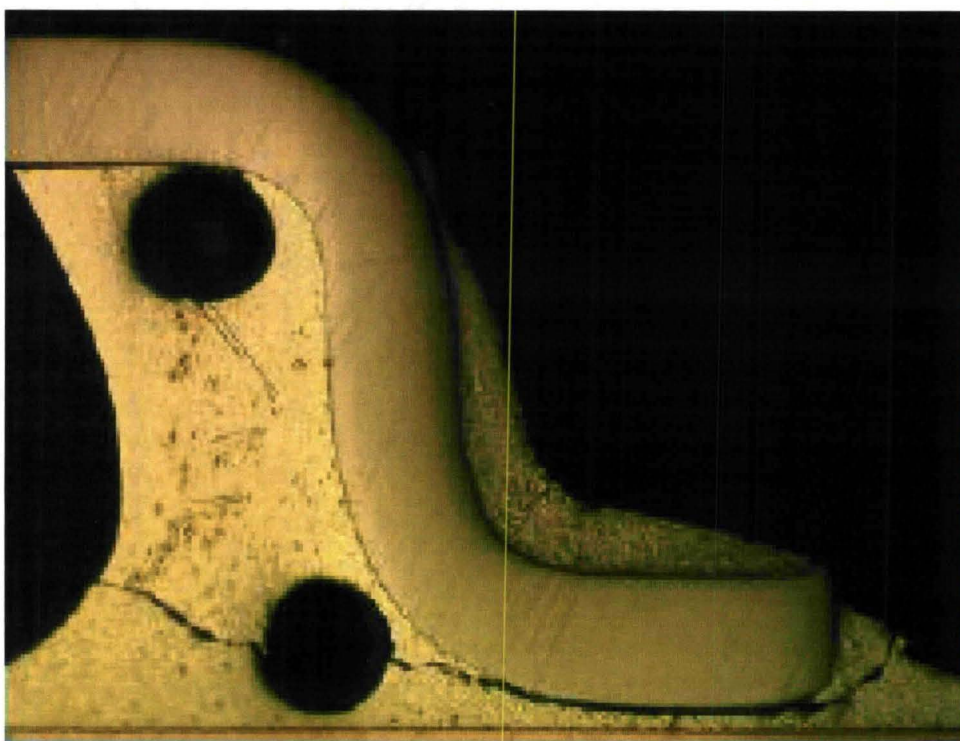
Figure 14 - SN66 U62, Right Lead

SN79 U12 (Figure 13) and SN66 U62 (Figure 14) are examples of TSOPs which did not undergo any re-work. They have Sn and SnBi finishes respectively. Both experienced severe solder cracking in leads on both sides of the component.

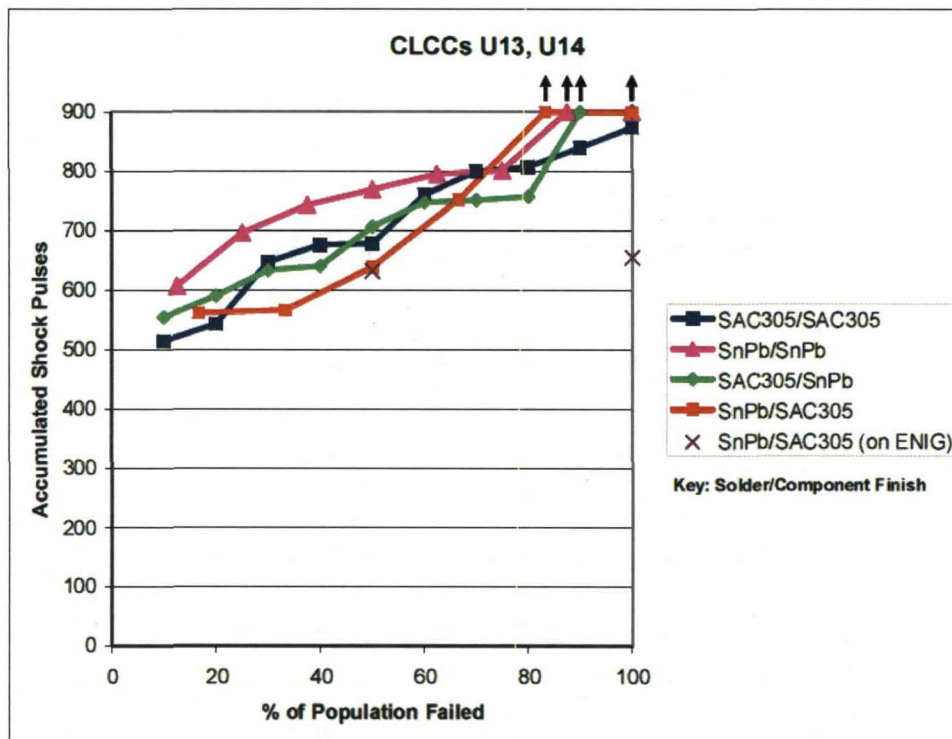
Figure 26 - Combined Data from CLCC's U13 and U14

For the CLCC-20 components, the SnPb/SnPb controls outperformed the combinations of SAC305/SAC305, SnPb/SAC305, and SAC305/SnPb (Figure 26).

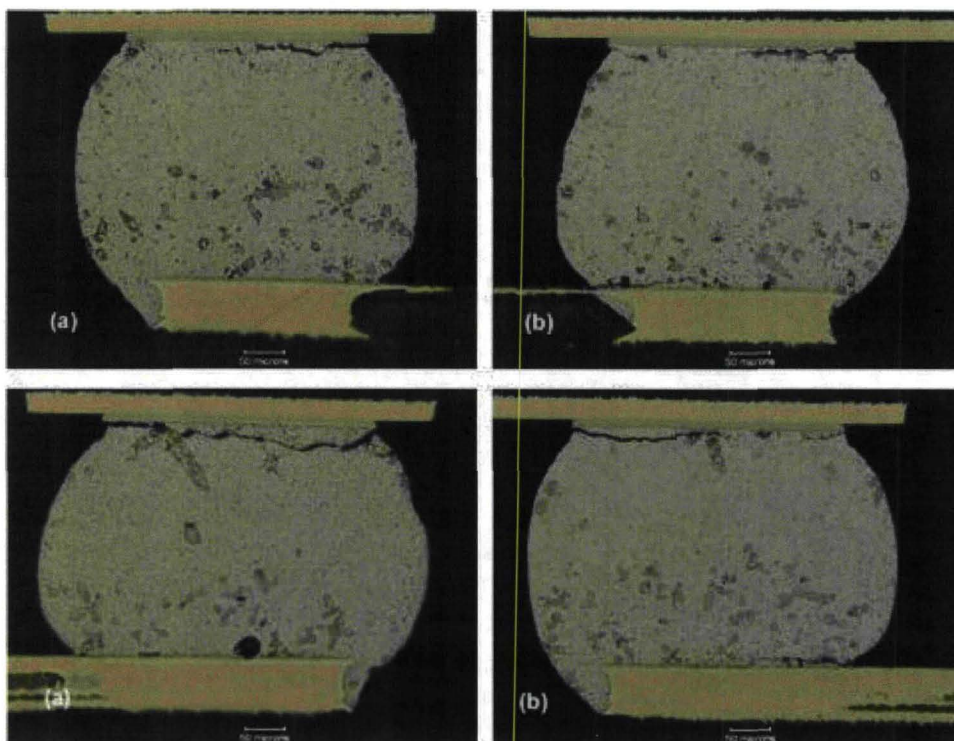
Figure 29 - Test Vehicle 34 – CSP U33

The combination of SAC305 solder/SAC105 balls generally performed as well as the SnPb/SnPb controls in mechanical shock. Microsections made at the end of the test showed that the corner solder joints failed first. The SnPb/SnPb solder joints formed cracks primarily on the component side (Figure 29). The SAC305/SAC105 solder joints formed cracks primarily on the component side and also showed evidence of pad cratering (Figure 30).

(a) Corner Ball, (b) Ball Adjacent to Corner Ball (SnPb Solder/SnPb Balls)

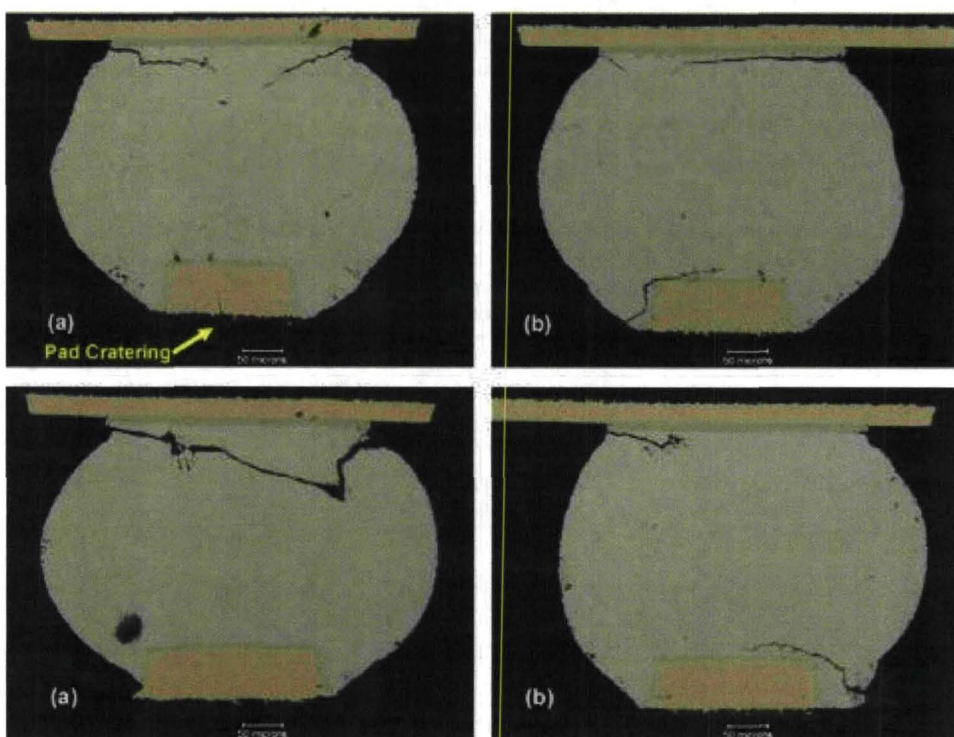
Figure 30 - Test Vehicle 89 – CSP U33

(a) Corner Ball, (b) Ball Adjacent to Corner Ball (SAC305 Solder/SAC105 Balls)

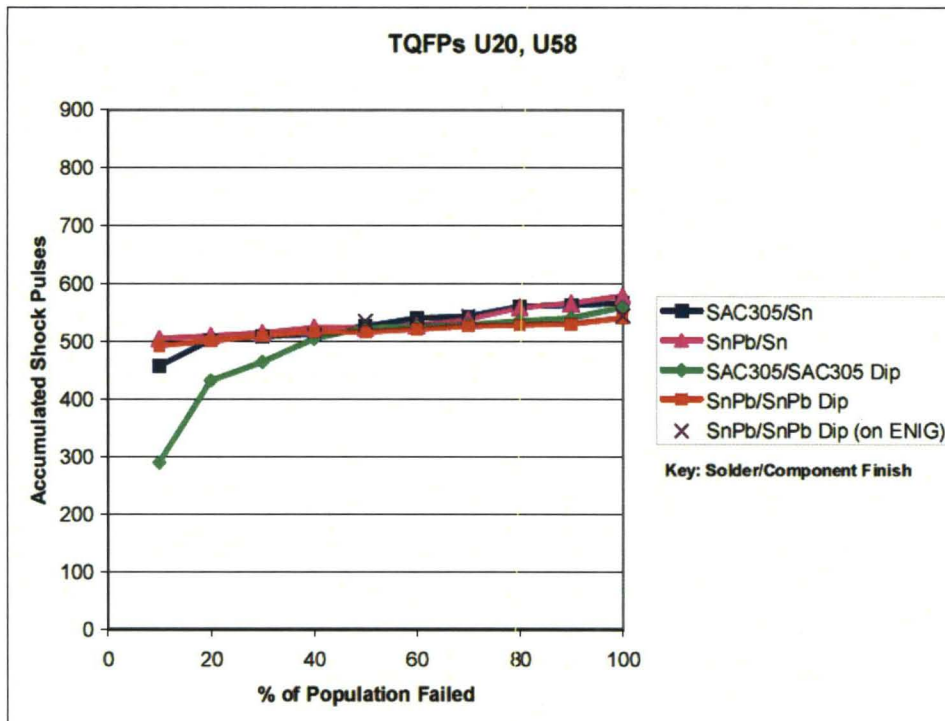
Figure 37 - Combined Data from TQFP's U20 and U58

For this test, some Sn-plated TQFP-144 leads were dipped into either molten SnPb or SAC305 to evaluate the effectiveness of the hot solder dipping on tin whisker formation. The combination of SnPb/SnPb Dip was equivalent to the SnPb/Sn control in performance but the SAC305/SAC305 Dip performance was inferior to that of the SnPb/Sn control due to some early failures (Figure 37).

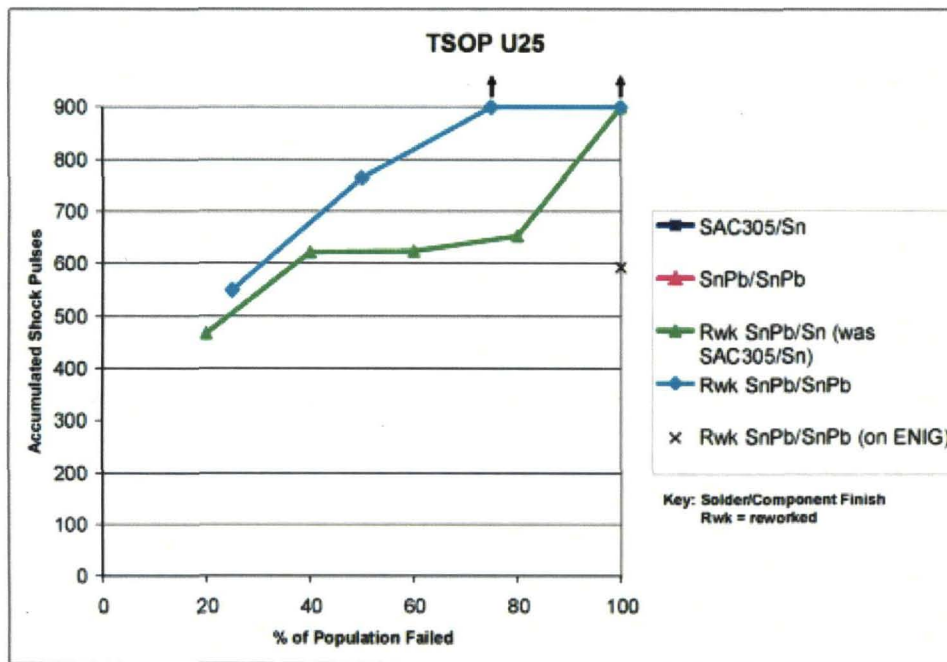
Figure 38 - TSOP U25 Data

Rework had a definite negative effect on performance. SnPb/SnPb reworked with SnPb/SnPb and SAC305/Sn reworked with SnPb/Sn underperformed the un-reworked SnPb/SnPb controls which had no failures (Figure 38).

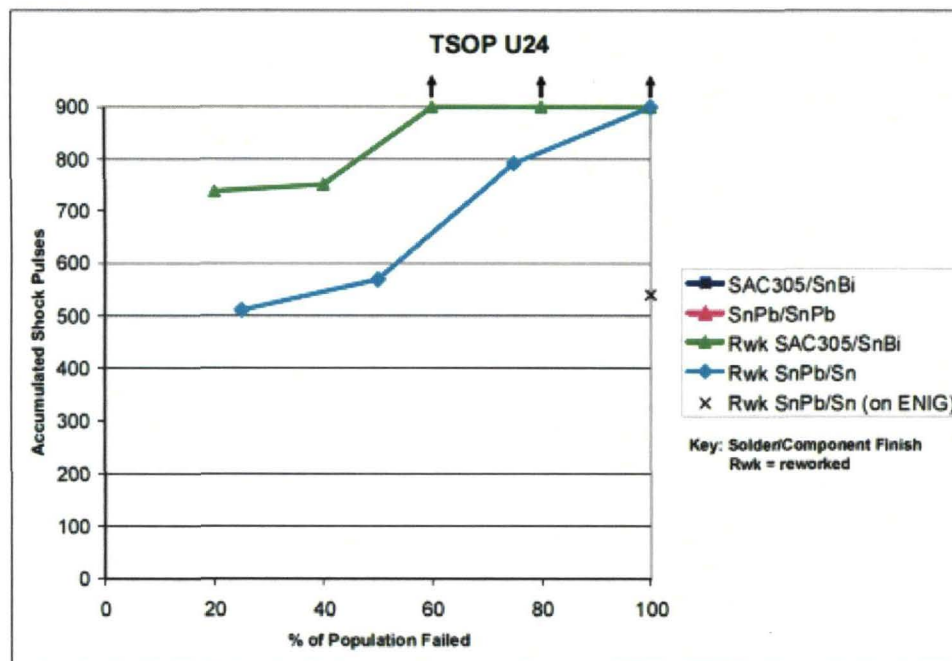
Figure 39 - TSOP U24 Data

SnPb/SnPb reworked with SnPb/Sn and SAC305/SnBi reworked with SAC305/SnBi underperformed the un-reworked SnPb/SnPb and SAC305/SnBi controls which had no failures (Figure 39).

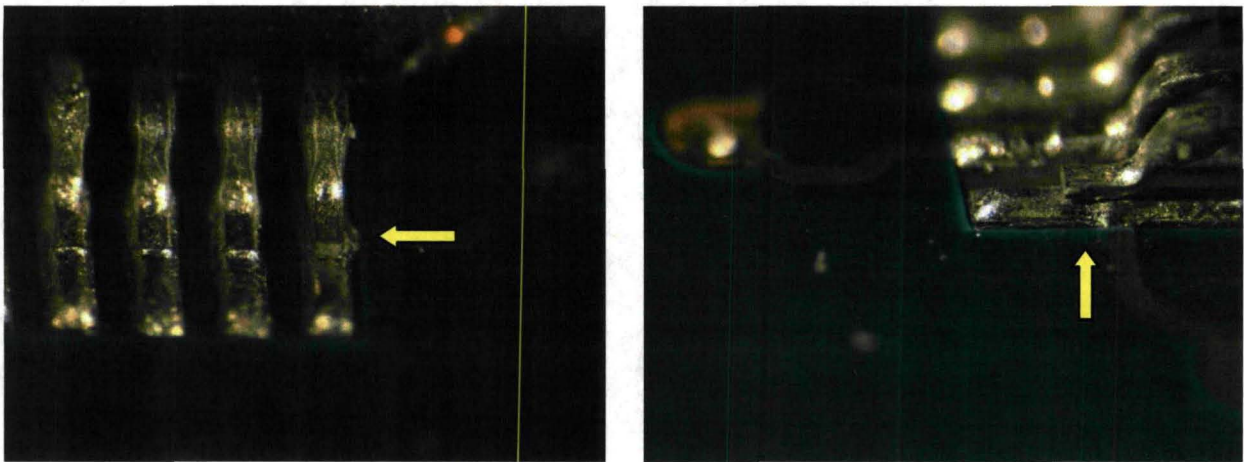
Component location U34 is a TQFP-144 component from SnPb manufactured (Batch C), soldered with SnPb on SnPb dip component finish. This component did not have a signal and failed before one complete cycle. Figure 41 is the optical micrograph showing insufficient solder observed on lead 72 at 49X magnification.

Figure 41 - TV21 U34; Optical Micrograph, Insufficient Solder Observed

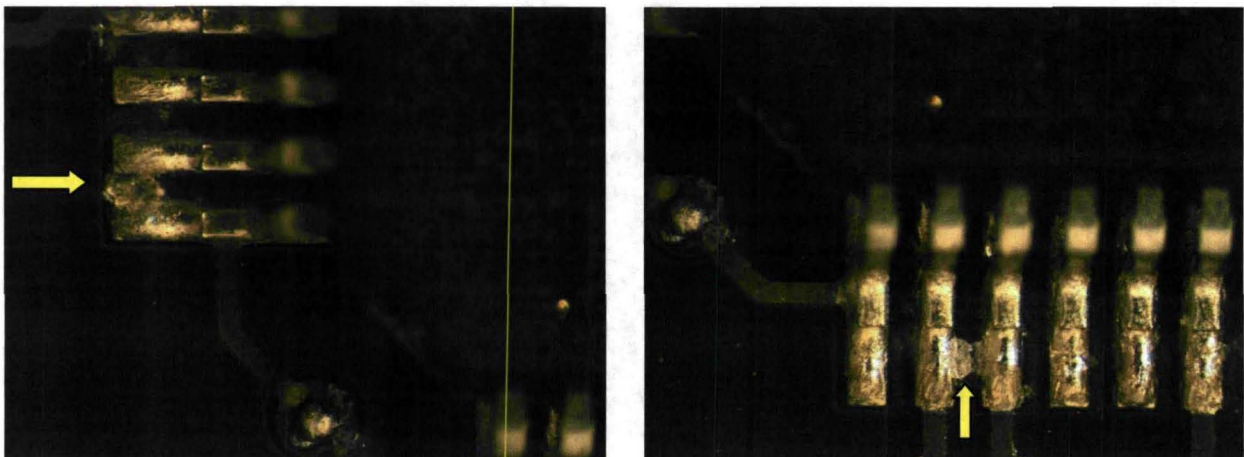
Component location U57 is a TQFP-144 component from SnPb manufactured (Batch C), soldered with SnPb on SnPb dip component finish. This component failed at cycle one. Figure 42 is the optical micrograph of residue that was found between leads in two locations. The image on the left shows residue between leads 35 and 36, magnified at 38X. The image on the right shows residue between leads 38 and 39, magnified at 38X.

Figure 42 - TV21 U57; Optical Micrograph, Residue between Leads

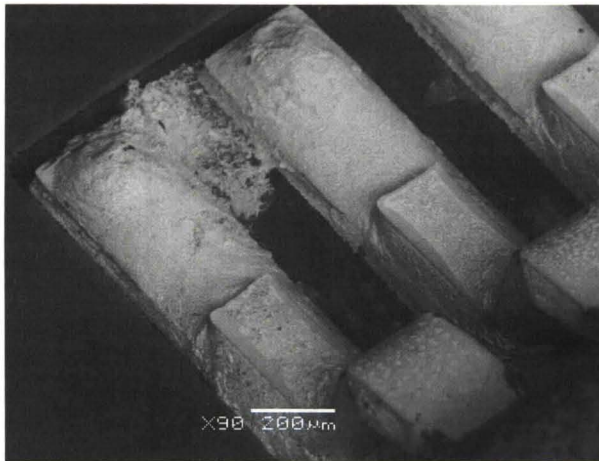
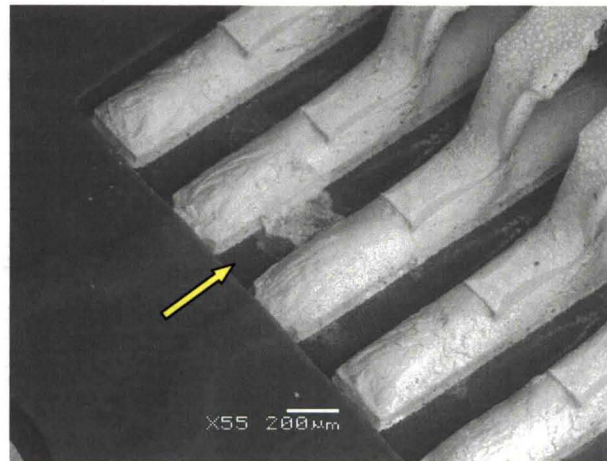
Figure 43 shows Scanning Electron Microscope (SEM) images taken of the residue found from the images in Figure 42. The image on the left shows the residue that was found between leads 35 and 36, magnified at 90X. The image on the right shows the residue found between leads 38 and 39, magnified at 55X.

Figure 43 - TV21 U57; Optical Micrograph, Residue between Leads

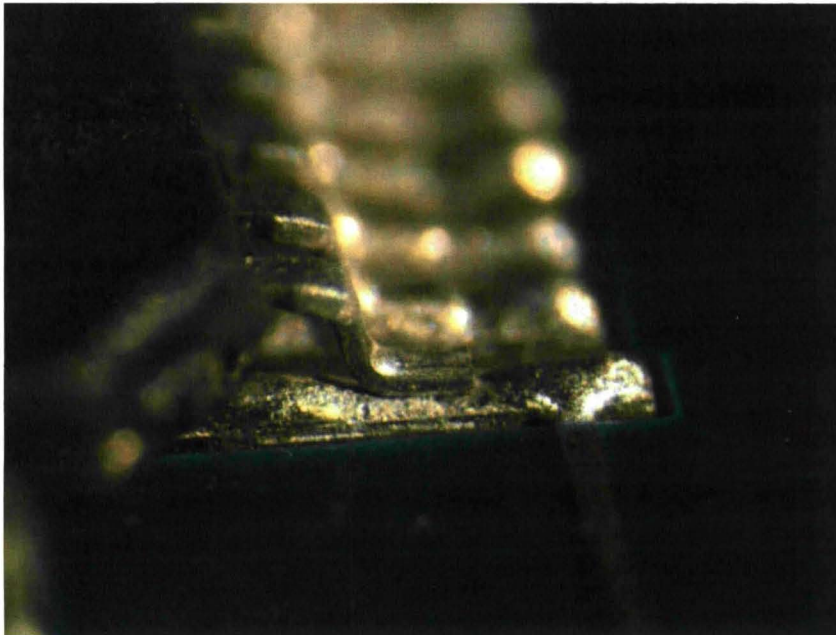
The possible cause for the immediate failure at cycle one can be found in the Figure 44. The Optical micrograph shows component lead 1 does not contact solder on PWB pad at 49X magnification.

Figure 44 - TV21 U57; Optical Micrograph, Component Lead 1

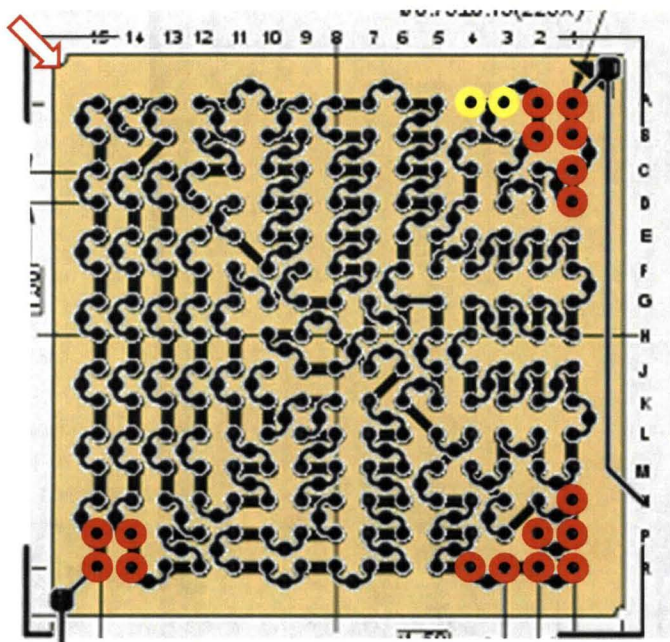
Figure 48 - TV23 U43; FA Results, BGA-225, Location U43

Component location U43 is a BGA-225 from the SnPb manufactured (Batch C), soldered with SnPb with SAC405 component finish located near the center of the test vehicle. This component failed at 120 cycles of combined environments. In Figure 48, yellow circles indicate solder joints with high resistance and red circles indicating failed solder joints that are open.

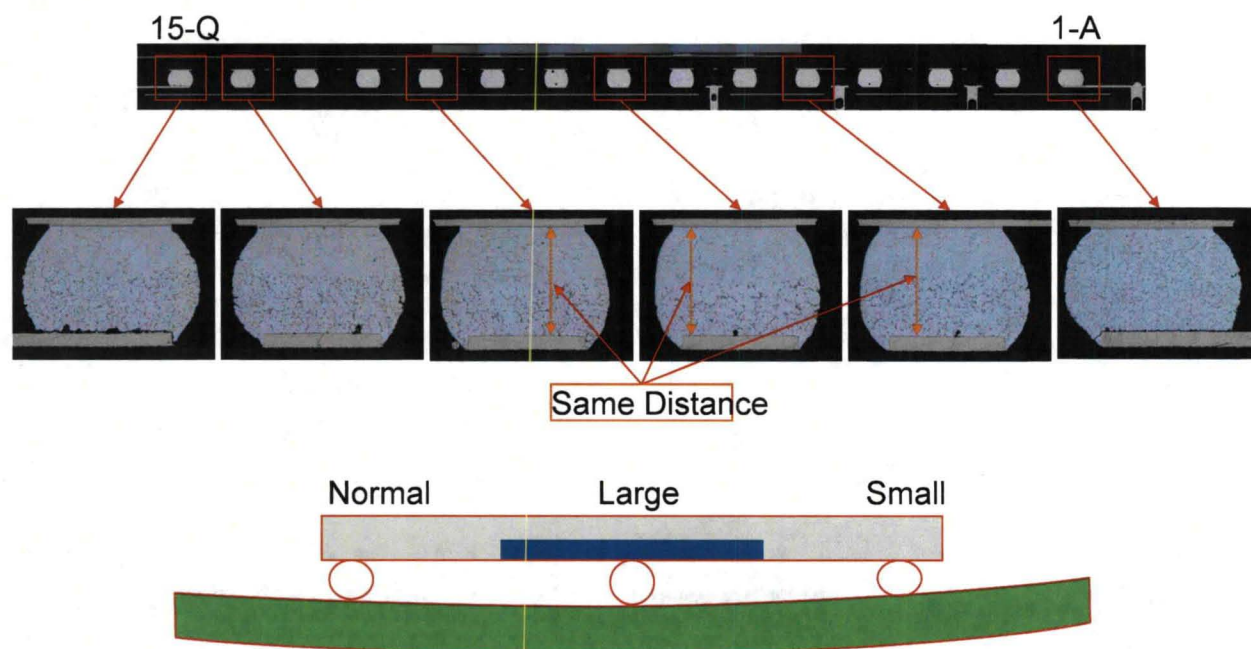
In Figure 52 the distance between component and board at each sphere is almost the same under the chip in the center. The distance becomes smaller further to the end. Comparing the distance at [1-A] and [15-Q], [1-A] has smaller distance.

Figure 52 - TV23 U43; Cross-Sectional Micrographs Show Warping

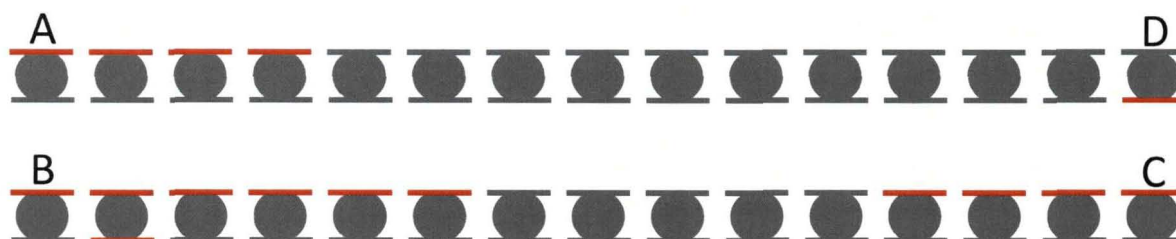
There was a progression of cracking between sides A/D and B/C, which can be visually represented in Figure 58. Red on top of the solder ball is cracking observed at the component interface. Red on the bottom of the solder ball is cracking observed at the PWB pad interface. Red on both the top and bottom of the solder ball is cracking observed at both the component and PWB pad interface. No red indicates an intact solder joint.

For this BGA-225 component, cracking was observed on both the second and third rows in from the perimeter row. No cracking was observed on solder balls beneath the component die.

Figure 58 - TV117 U4; Diagram Showing Progression of Cracking in Component

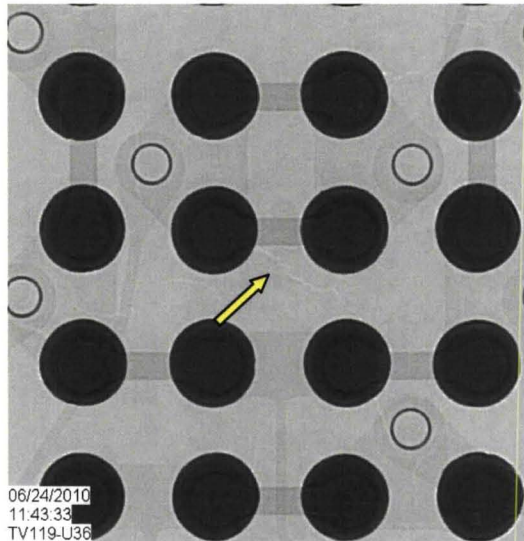
Figure 59 - TV119 U36; X-Ray Image, CSP-100

Figure 59 is an x-ray image of the center region of the CSP-100 component in location U36. The PCB solder mask has a crack and is not homogeneous.

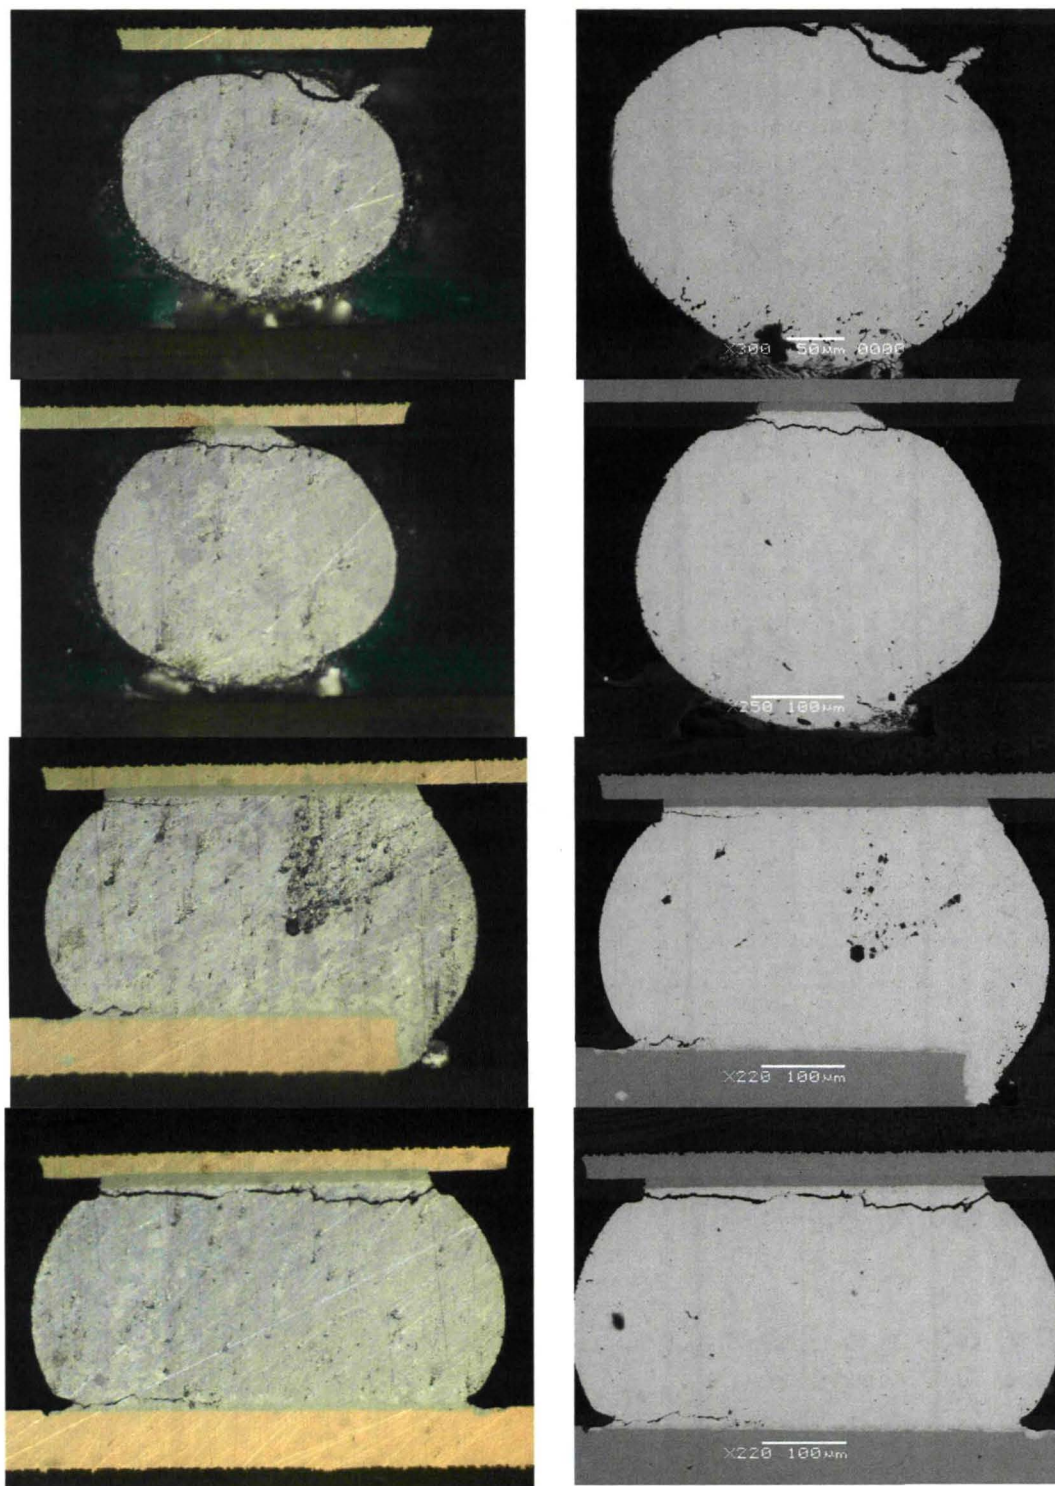
Figure 61 - TV119 U36; Cross-Sectional Micrographs of Solder Balls A1, A2, A9 and A10

In Figure 61, on the left, cross-sectional micrographs of solder ball A1, A2, A9 and A10, at 274X magnification. On the right, the corresponding SEM images for solder ball A1 (300X), A2 (250X), A9 (220X) and A10 (220X).

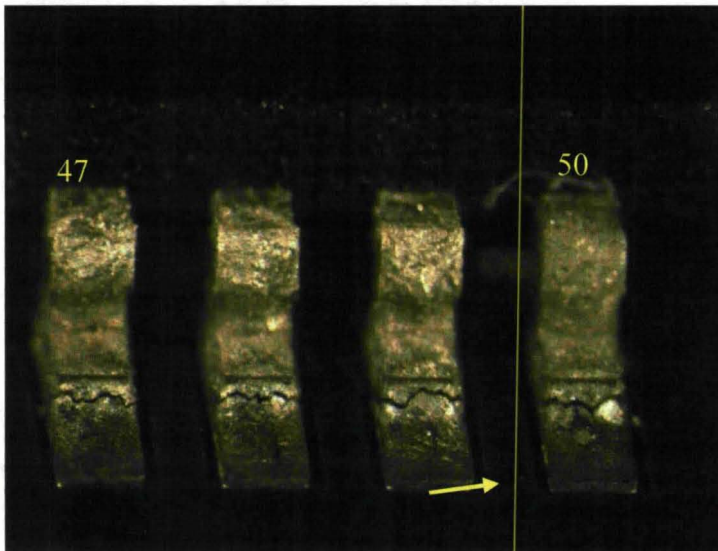
Figure 62 - TV119 U39; Optical Micrograph at 49X Magnification

Component location U39 is a TSOP-50 component from lead-free manufactured (Batch G), soldered with SN100C solder paste on SnPb component finish. This component was surrounded by components that fell off during testing and failed after 318 cycles.

Figure 62, an optical micrograph at 49X magnification showing cracked solder joints and cracks in the solder mask between leads 47 and 50.

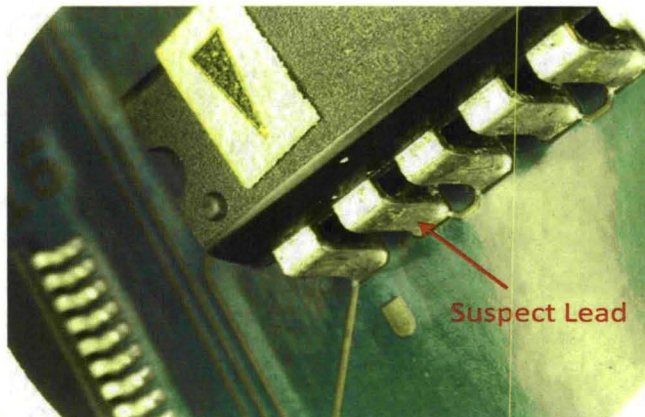
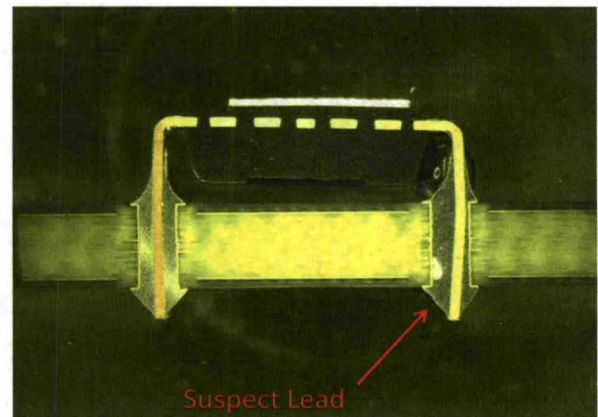
Figure 67 - TV140 U11; Optical Micrograph

Component location U11 is a PDIP-20 from SnPb rework (Batch B), soldered with SnPb on SnPb component finish. This component had a damaged pad from the rework process and failed after 398 cycles. For the optical micrograph in Figure 67, on the left shows the suspect lead. Cross-sectional micrograph on the right is the suspect lead.

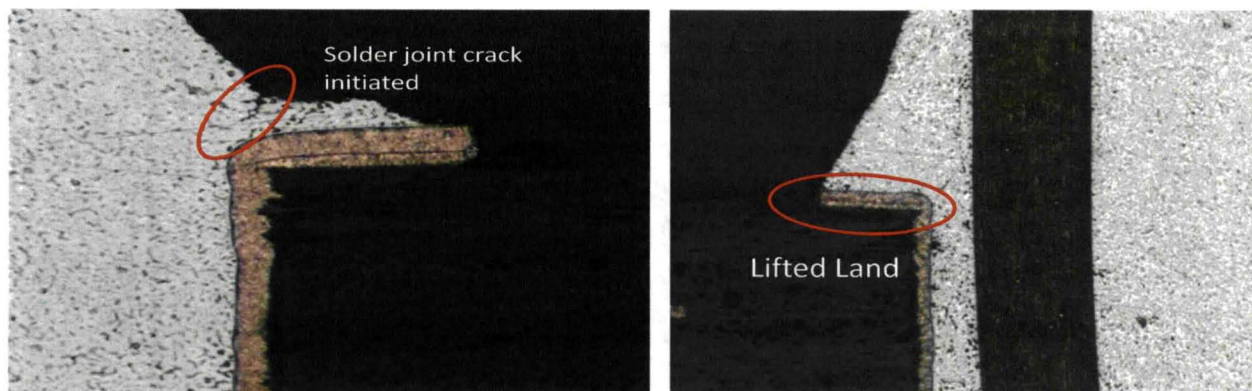
Figure 68 shows the cross-sectional micrographs of the suspect lead in the PDIP-20 component showing solder joint crack initiation and lifted land.

Figure 68 - TV140 U11; Cross-Sectional Micrographs, Suspect PDIP-20 Lead

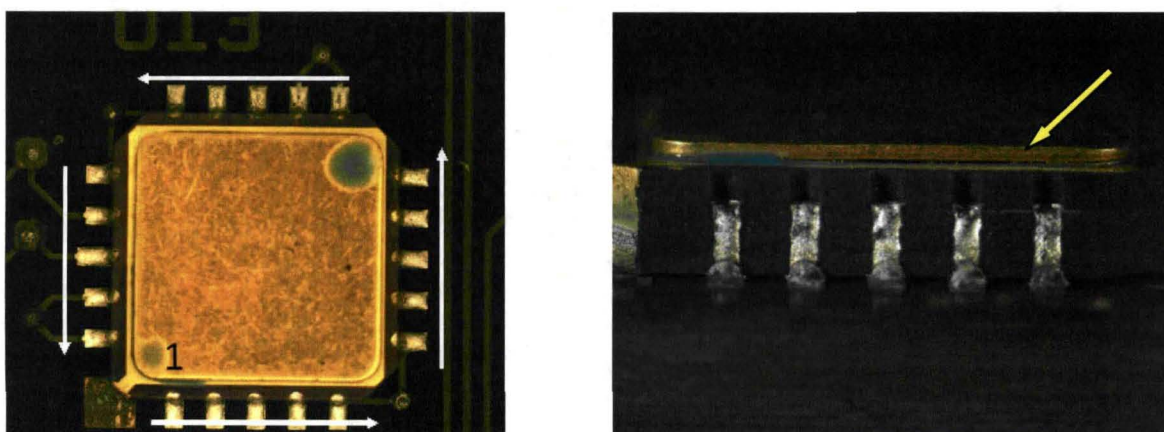
Figure 69 - TV142 U13; Optical Micrograph, CLCC Package Lead

Figure 69, optical micrograph, on the left shows the CLCC package lead numbering. Micrograph on the right shows an improperly sealed lid on the side for leads 1 – 5 where lead 1 is on the left at 19X magnification.

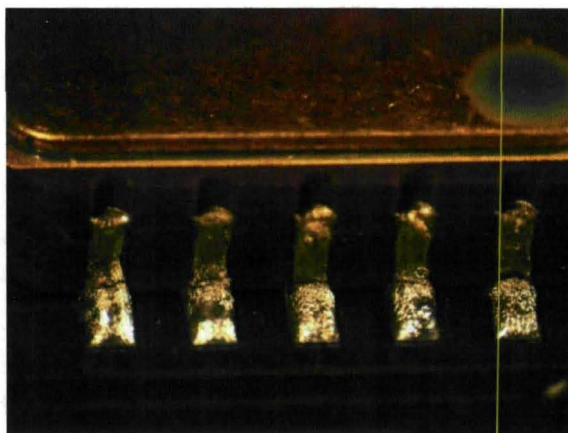
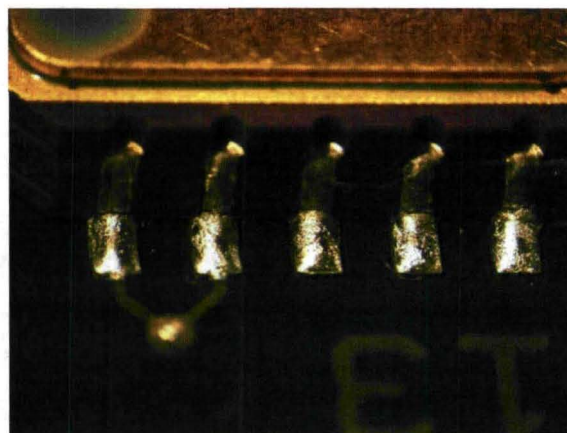
Figure 70 - TV142 U13 Optical Micrographs of CLCC-20 Leads at 24X Magnification

For Figure 70, on the left are leads 6 – 10 starting with lead 6 on the left and on the right are leads 11 – 15 starting with lead 11 on the left. Minor solder cracking is visible.

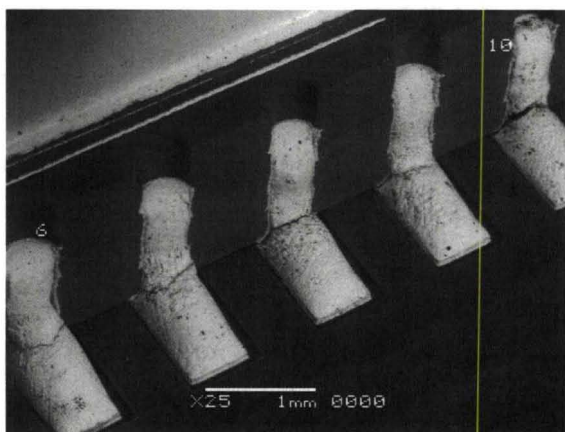
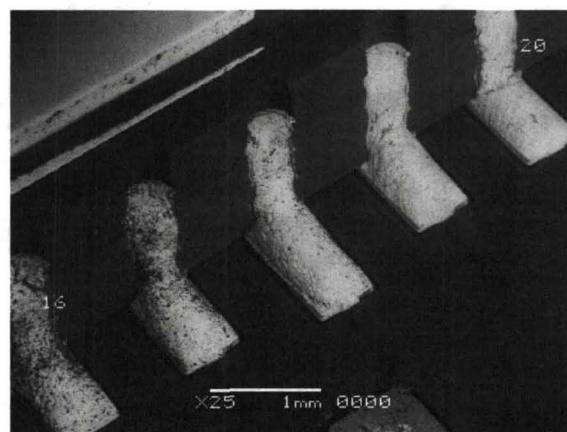
Figure 72 - TV142 U13 SEM Images of Component at 25X Magnification

In Figure 72 on the left are leads 6 – 10 which have some visible solder cracks and on the right are leads 16 – 20 and do not have solder cracks.

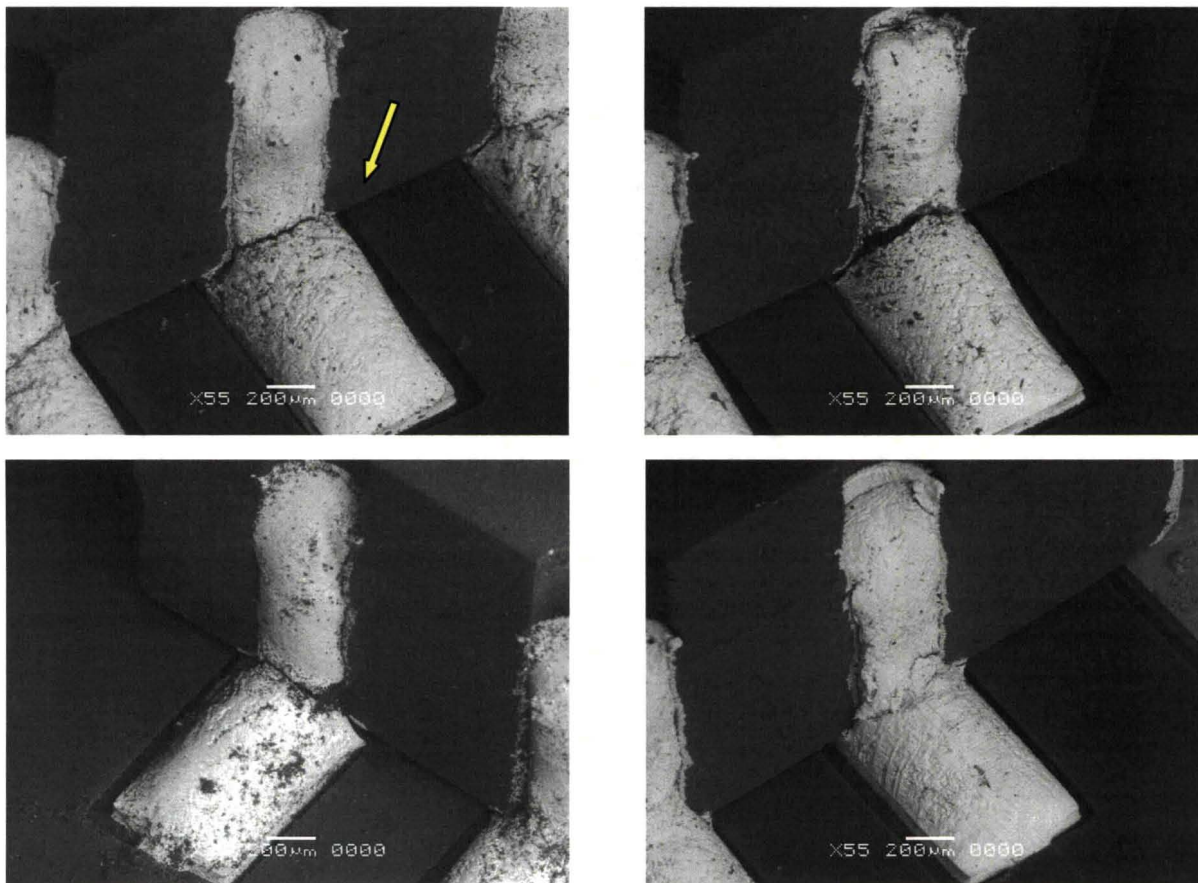
Figure 73 - TV142 U13 SEM Images of Selected Leads at 55X Magnification.

In Figure 73, the upper left image is lead 8 where the arrow indicates a solder crack. The upper right image is lead 10 where a solder crack is also visible. The lower left image is lead 11 and the lower right image is lead 20.

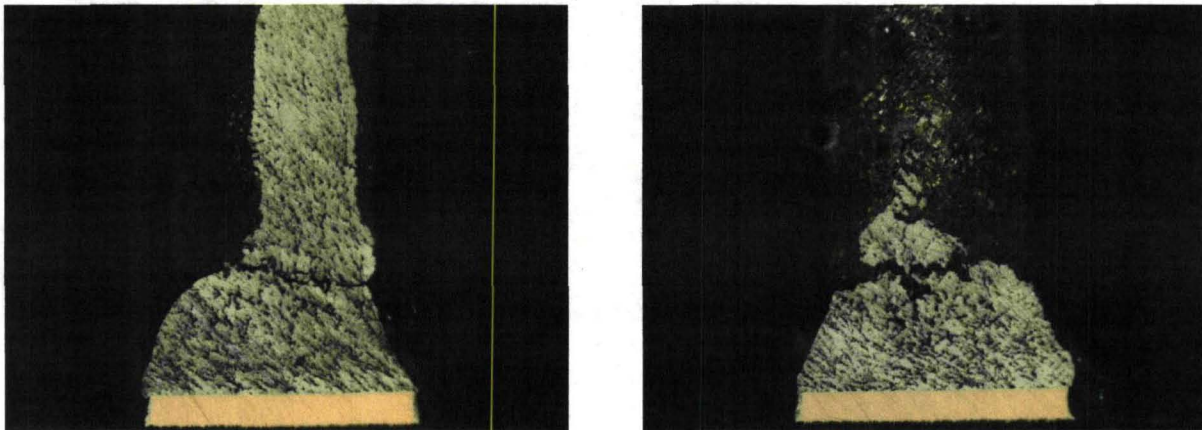
Figure 75 - TV142 U13; Cross-Sectional Micrographs of Lead 1 and Lead 5

Figure 75, cross-sectional micrographs of lead 1 (left) and lead 5 (right) solder joints, grinding level A, at 136X magnification.

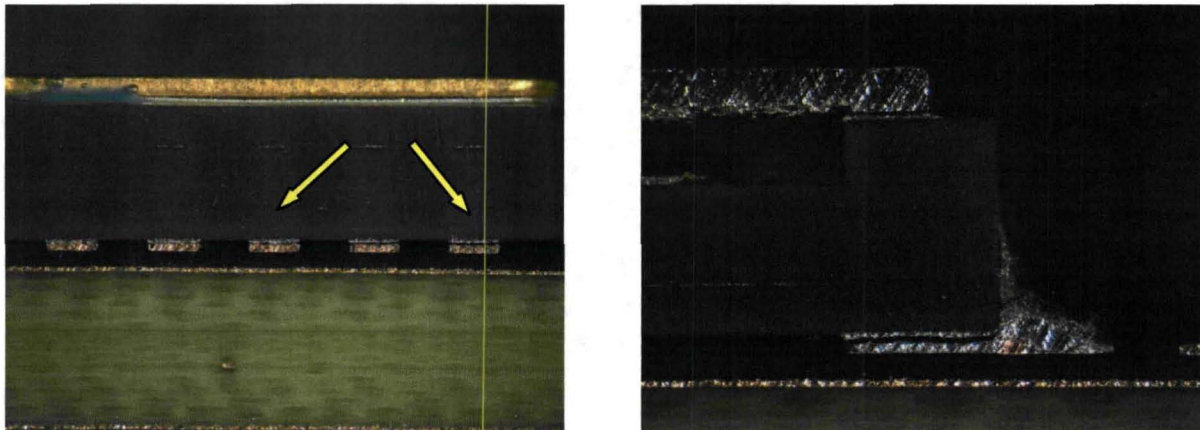
Figure 76 - TV142 U13; Cross-Sectional Micrograph

Figure 76, cross-sectional micrograph, on the left shows grinding level A of leads 1 – 5 where the arrows indicate separation of the solder joints from the copper pads at 24X magnification. Micrograph on the right is lead 6 at 38X magnification just prior to grinding to level B.

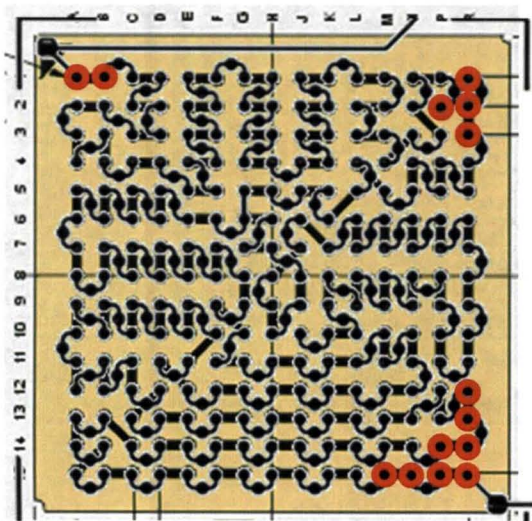
Figure 78 - TV158 U6; FA Results

Component location U6 is a reworked SnPb BGA-225 component soldered with SnPb solder paste, removed and replaced with a SAC405 BGA-225 component soldered with SnPb solder paste on an ENIG PWB. This component failed during the first cycle.

In Figure 78, the red circles indicate failed solder joints that are open.

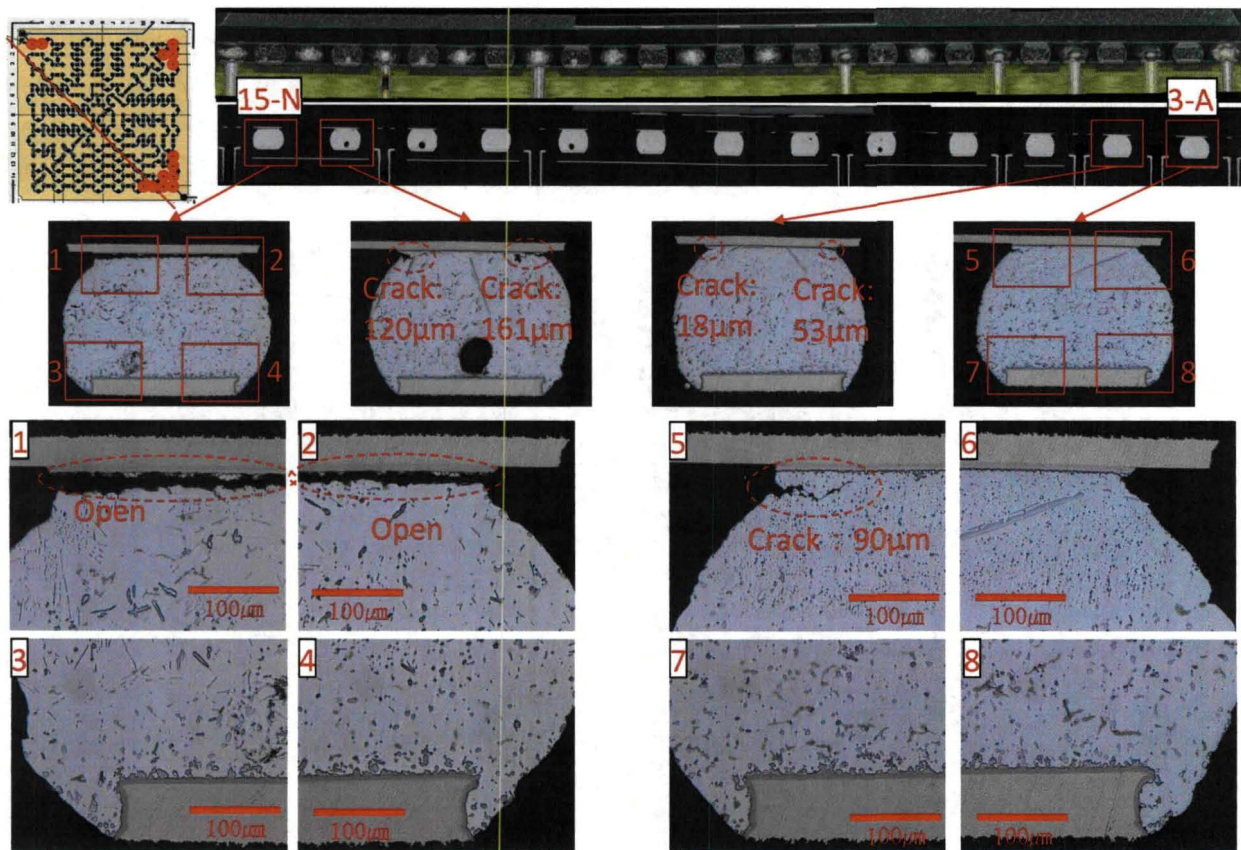
Figure 79 - TV158 U6; Cross-Sectional Micrographs

The cross-sectional micrographs in Figure 79 show different solder structure in lands on board (7, 8) and lands on component (5, 6). Cracking to open along component land observed at 15-N.

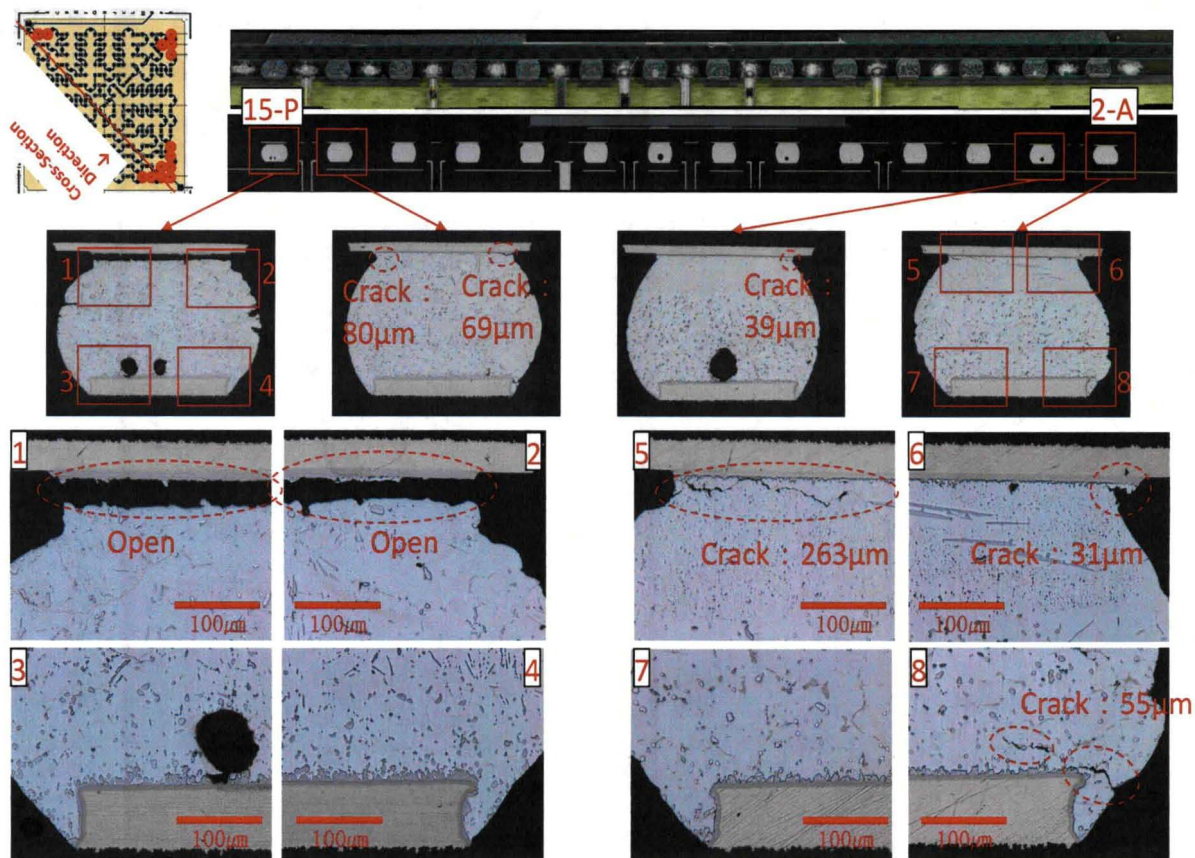
Figure 80 - TV158 U6; Cross-Sectional Micrographs

Figure 80 cross-sectional micrographs show different solder structure in lands on board (1, 2, 7, 8) and lands on component (3, 4, 5, 6). Cracking to open along PWB land found at 15-P.

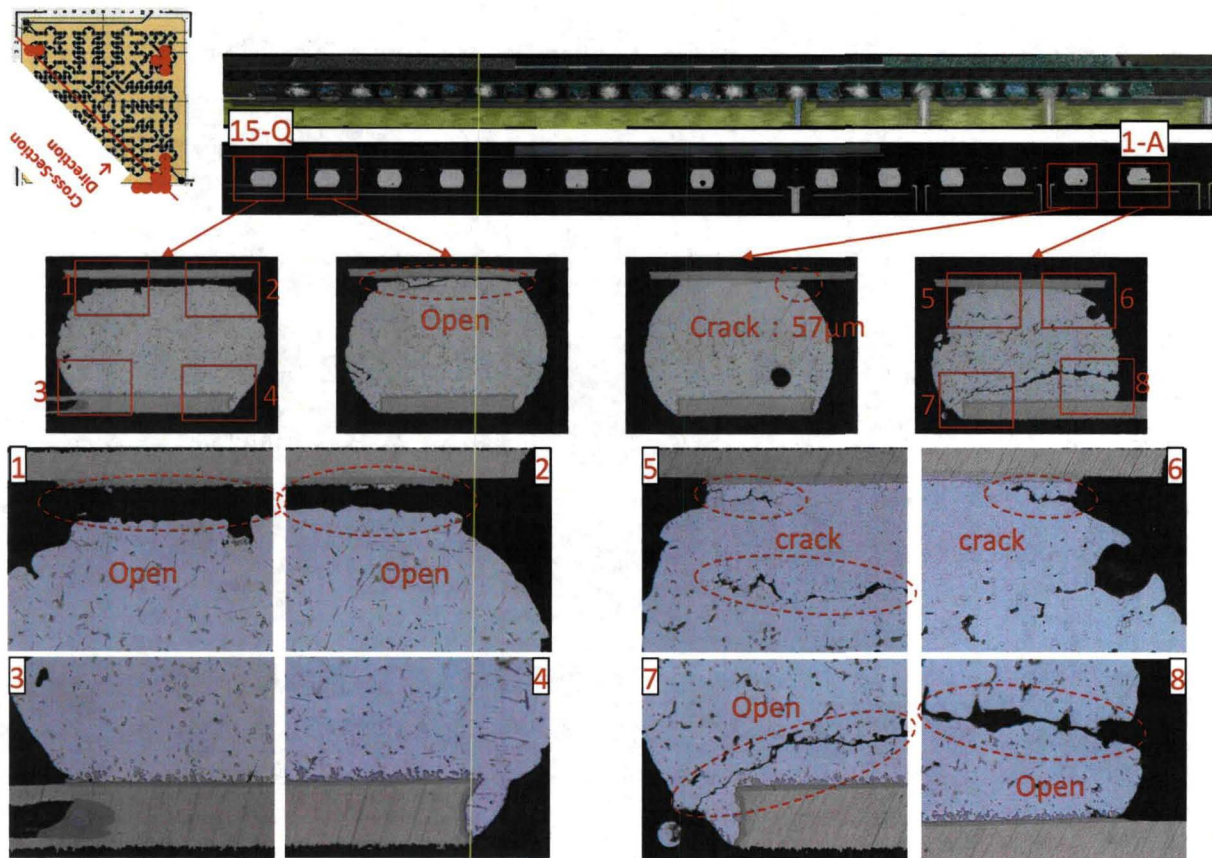
Figure 81 - TV158 U6; Cross-Sectional Micrographs

Cross-sectional micrographs in Figure 81 show different solder structure in lands on board (7, 8) and lands on component (5, 6). Cracking to open inside solder found at 1-A. Open joint along land on component found at 15-N.
